The Hows, Whys and Fixes for Pegasus "Jitter"

Recent investigations into the reasons and possible cures of Pegasus screen Jitter have revealed that there are at least 4 distinct causes. This report explains the theory behind these causes and suggests some modifications to erradicate the jitter.

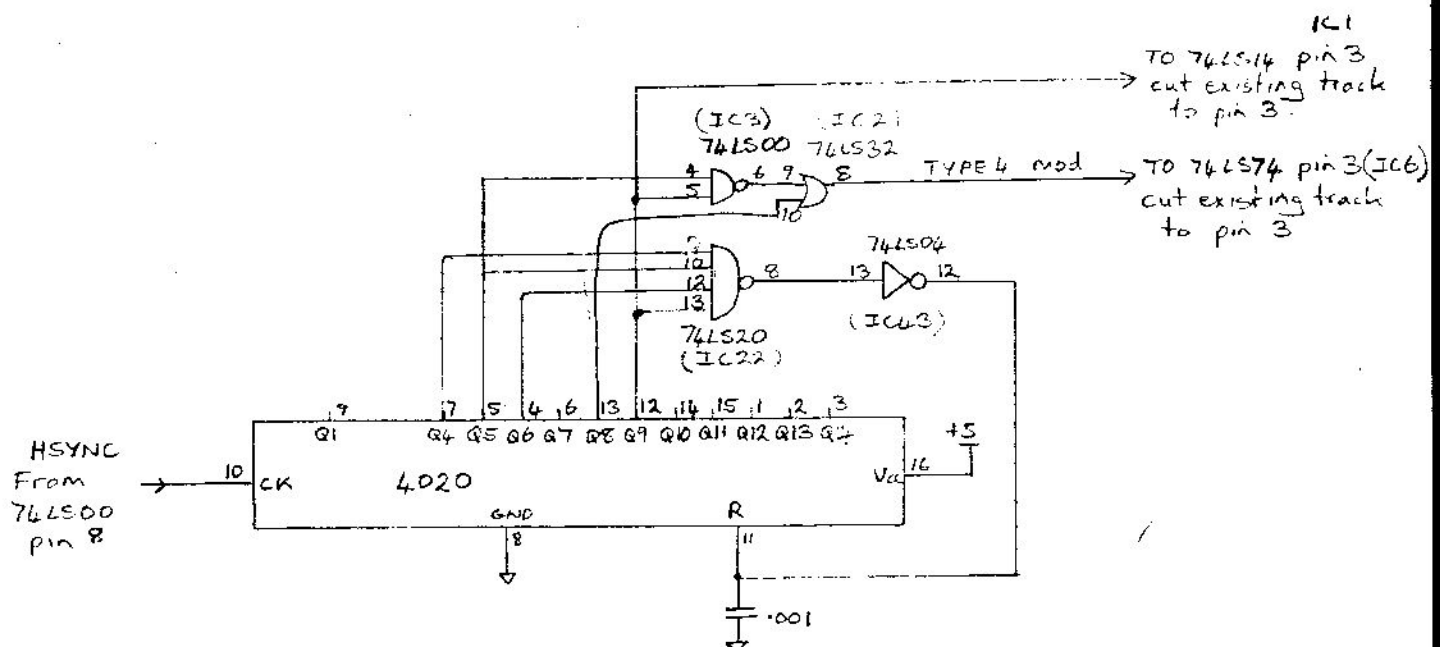
The frame rate for the video is initiated by a signal derived from the mains; Once the frame is started, everything is locked to the processor clock. So while the picture information doesn't jitter with respect to HSYNC and VSYNC, the frames themselves do jitter with respect to each other. In other words the VSYNC signals are not regular. Sometimes they are $X \times 64 \text{ us}$ (HSYNCS occur every 64 us) apart and sometimes they are $(X + 1) \times 64 \text{ us}$ apart. Normal TV sets have an oscillator which likes to lock to regular VSYNC pulses. It will infact lock to a frequency with a period somewhere between $X + 1$ and X times 64 us . Then what you get is a picture sometimes slightly above and sometimes slightly below the true position. The cure is to use some kind of divider to derive your 50Hz from the processor clock, instead of the mains. The following mod uses one IC and some existing gates on the Pegasus board.

The 74LS20 gate has tracks running to it which must be cut.
 The 74LS04 becomes free from a modification to the dot clock
 oscillator which was given to us by G. Barbour of Christchurch.
 This modification stops shimmer on the displayed characters
 and stabilizes the oscillator frequency.

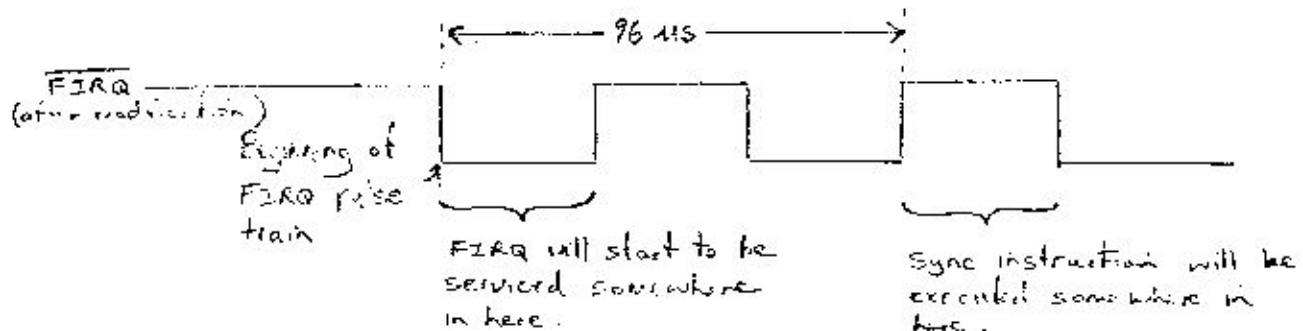
The FIRQ pulses generated by the existing Pegasus hardware are 8 μ s long. The 6809 chip however only checks the FIRQ pin after each instruction. Since 6809 instructions can take up to 20 μ s it is clear that it is possible for the chip to miss on FIRQ pulse. If it "sees" the following one then the whole picture will be 64 μ s too late i.e. one scan line too low on the screen. This causes jitter whenever programs with longish instructions are running.

From this drawing it can be seen that 32 μ s is the ideal length for the FIRQ pulse (which is active low) because it gives an equal mark space ratio square wave. If the FIRQ pulse were any longer, then the period in which the FIRQ line is high becomes correspondingly shorter and it is then possible for the SYNC instruction to occur while the FIRQ line is low, giving sideways jitter.

If the FIRQ pulse is shorter than 20 μ s it is possible for them to be missed by the processor. In fact the full 32 μ s is better because it allows the programmer to mask off FIRQs for two or three instructions if he wishes, without missing an FIRQ.

The cure for Type 2 jitter is to take the FIRQs from the 74LS93 divider, IC7 pin 9. This is a square wave with 32 μ s each way. This modification also needs a new monitor version 2-3. The delays in this monitor are adjusted so that a) the picture is in the middle of the screen and b) the SYNC instruction is 96 μ s after FIRQ starts to be serviced. This ensures that the SYNC instruction is not executed while the FIRQ line is low, which would cause terrible sideways jitter.

So 32 us FIRQs are used. The time from the start of servicing of the FIRQ to the SYNC instruction in the monitor is adjusted to be 96 us. Also since the new FIRQs are out of phase with the old ones, the monitor has its delay that positions the picture in the middle of the screen adjusted.

The actual modification is done by cutting the track to the 74LS32 pin 5 and jumping this pin to the 74LS93 pin 9 (IC7) and getting a version 2-3 monitor.

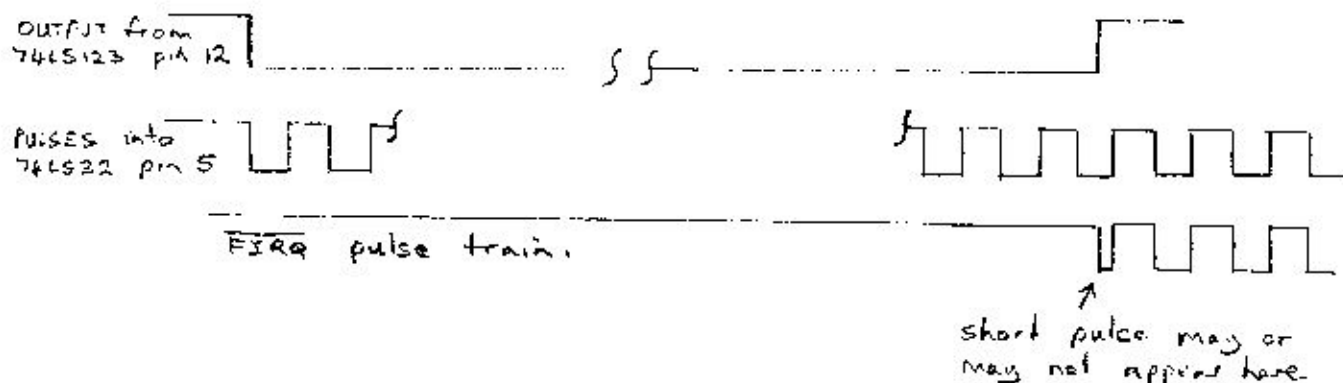
The timing from the VSYNC pulse to the start of the FIRQ burst of pulses is done by a 74LS123 one-shot. The delay is approx 3 ms, and since this is timed from an R-C network it cannot be set accurately. If the end of the delay comes during the time that the FIRQ pulse is low, then a small FIRQ pulse will be given to the processor before the burst of full length ones.

Since the pulse can be very short the processor may or may not "see" it. The 123 delay drifts with time and so the jitter will come and go.

The cure is to clock IC46 b with FIRQ pulses instead of E. This F/F is redundant as it is anyway. The existing track to the 74LS74 pin 11 (IC46) cannot be cut as it is underneath the IC. Instead it must be cut in two places and then 2 jumpers need to be put in.

Cut the track running from IC46 pin 11 to the system PIA pin 25 and also cut the track running from IC46 pin 11 just before the hole where it goes through the board and on to pin 3 of the 74LS04 oscillator. (IC43). Now join this hole back to the PIA pin 25. Now join IC46 pin 11 to the 74LS32 pin 5 (IC2). Note that this half of IC46 does not appear in the drawings but it is used in the circuit.

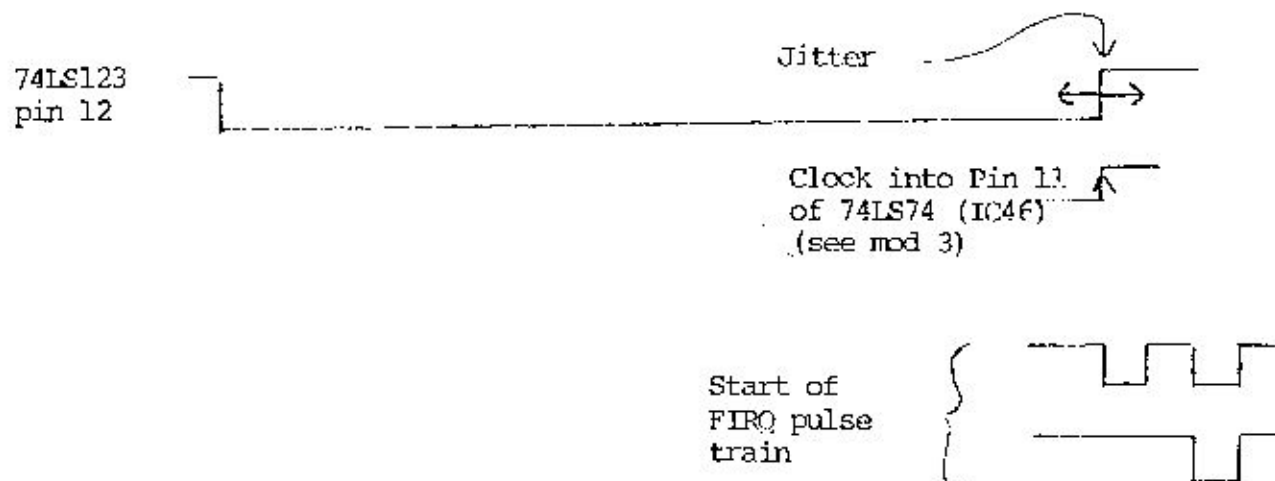
Type 4 jitter is again caused by the 74LS123. Using an oscilloscope it can be seen that a noticeable jitter occurs in the delay pulse whenever the Pegasus is running a program. When the trailing edge of the pulse falls on or near the clocking point explained for type 3 mod then the jitter in the 123 will cause the first FIRQ pulse to appear sometimes latter and sometimes earlier.

The only way to get round this is to bypass the 74LS123 altogether and use some pulses derived from the Type 1 jitter mod. (see the drawing for the 4020 mod). The existing track to 74LS74 IC6 pin 3 must be cut and taken to the spare nand gate as shown. This will give a picture nicely in the middle of the screen. (vertically)
